## Feed Thru Filters and Silver Migration

Surface migration of the plating metal on feed-thru bodies causing apparent low resistance to ground failures has been long been noted. This is caused by both the presences of both a DC voltage and a water path from ground to the center pin. This article discusses the phenomenon of ion migration, what to look for, leakage characteristics of different materials, and how to design around the problem.

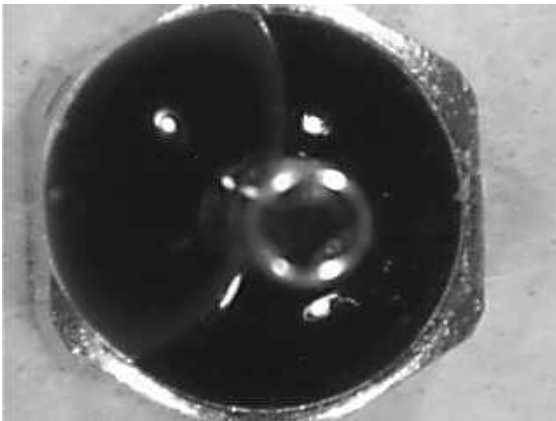
Migration makes itself known as a low resistance failure of the bulkhead mounted filter. If the current is high enough, the migration tendril will burn through and the circuit will have seemed to repair itself. However, if moisture returns, the tendril will grow back and an intermittant short situation may be apparent. Migration looks like a grey film on the sealing glass or epoxy of the feed-thru. This migration is strictly a surface phenomenon, once removed by slight mechanical action; the filter will function as designed. In fact, many who come across this problem inadvertently wipe the dendrites off when removing the part for further testing. Photo 1 illustrates the balling of water on sealing epoxy and photo 2 illustrates the dendritic growth after a DC voltage is applied.

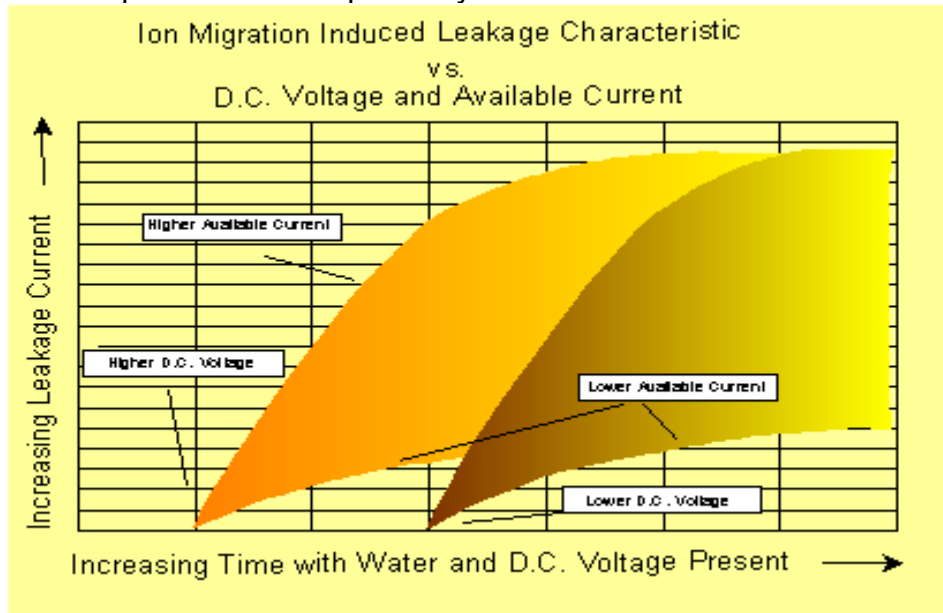
leakage. Graph 1 illustrates this general relationship between voltage and available current on leakage rates. Graphs 2 and 3 illustrate actual leakage examples of silver and 90tin/10lead plated filters respectively.
